**BUILDING SURVEY REPORT**

**70 Smith Road**

AS INSPECTED BY ABC SURVEYS LIMITED

On: Wednesday 14<sup>th</sup> June 2017

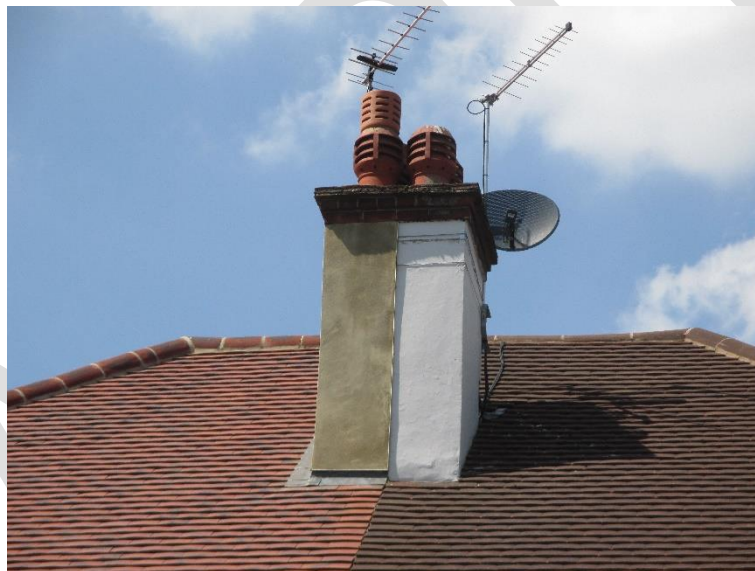
There is a shared brick/rendered built chimney stacks serving the subject property located to the party wall line of the property and shared with the neighboring property to the front and rear elevations.

A chimney stack built during this era would not necessarily have incorporated a damp-proof course and it is therefore essential to maintain the condition of the brickwork and render in order to prevent such dampness occurring.

Aerials fixed to the chimney stack can cause damage to the brickwork and render and will require to be periodically examined.

Otherwise, we found no significant signs of any cracking or damage evident of the chimney stack where visible to inspect.

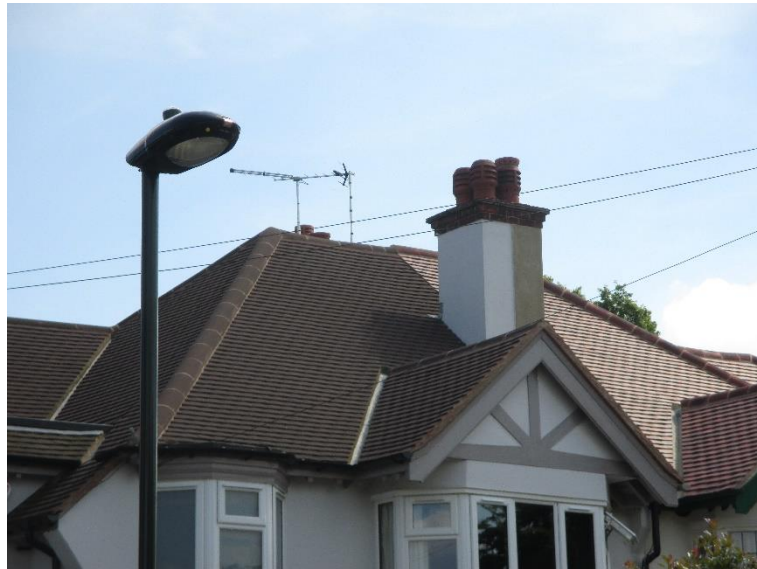
The main roof to the property is of timber pitched construction covered with small clay roof tiles and half round ridge and hip tiles.

The roofs are lined in a clay tile. The roof was found to be in reasonable condition at the time of our survey.

We noted some evidence of lichenous deposits to the surface of the roof tiles and, ideally, these should be brushed off as these can cause deterioration of roof coverings and if they become dislodged in gutters they can cause blockages and damp penetration problems to the structure beneath.

The general condition of the roof tiles were found to be in serviceable Condition. It is important to maintain the condition of these tiles, not only to secure them but to render these parts of the roof weather-tight.

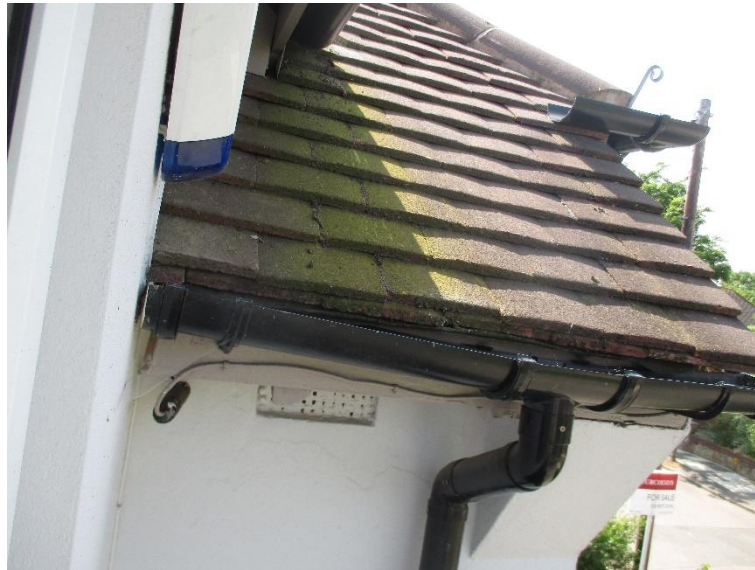
The rainwater pipes and gutters are formed in modern plastic incorporating half round sections to the gutters and down pipes to the main house. Generally, these were found to be in reasonable condition with no obvious signs of leak-ages evident.

The gutters and gullies should be cleared on a regular basis of leaves and other debris. Blocked gutters and gullies can result in serious rainwater penetration problems and consequential water damage to surfaces.

1. Overhaul/clean rainwater gutters and downpipes and reconnect rear guttering to down pipe.
2. External repairs and decoration (maintenance)
3. Inspect drainage
4. Allow for repointing some missing pointing to the main walls above front plinth.

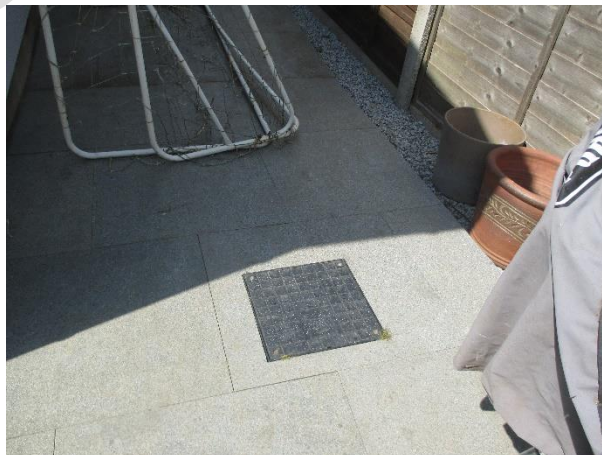
Within the curtilage of the property, the inspection chamber is situated in the side passage way adjacent to the boundary fence, which provides access to the underground drainage system. Access was gained by lifting the inspection chamber lid. The precise condition of the drains can only be verified by testing.

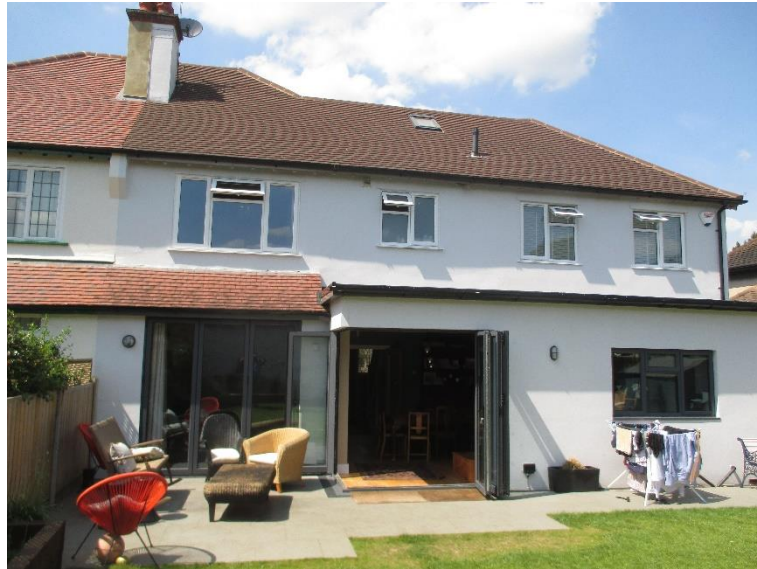
The main walls to the property are of cavity wall construction with a render finish and face brickwork to the front low level areas. Some weathered and missing mortar to the front elevation main walls will require repointing to maintain just above the bay window plinth (very minor)

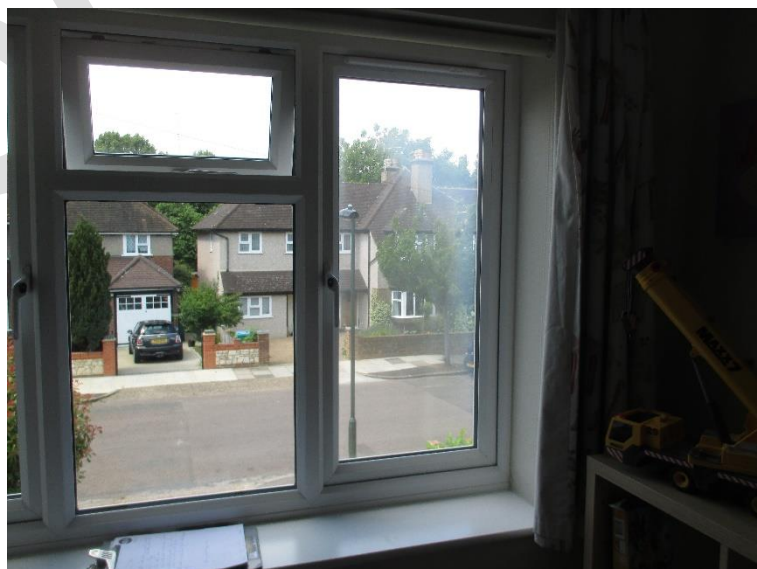
External joinery is limited to the main front door, framework, and fascia and soffits. General redecoration and maintenance is required to the fascia and soffits in order to protect the wood from decay.

The vacuum seal in the front left bedroom has failed, showing a missing to the glazing.

The vacuum seals to the double-glazing are prone to failure, and are particularly unreliable in older double-glazed units. If the vacuum seals fail the affected glazing will need to be replaced, which could prove problematic unless there is an easy means of removing the affected glazing. Following amendments to the Building Regulations all window installations after April 2002 are subject to approval under the Regulations and therefore it is important to ensure that any recent window replacement has the necessary approval or has been undertaken by an authorised installer (FENSA).

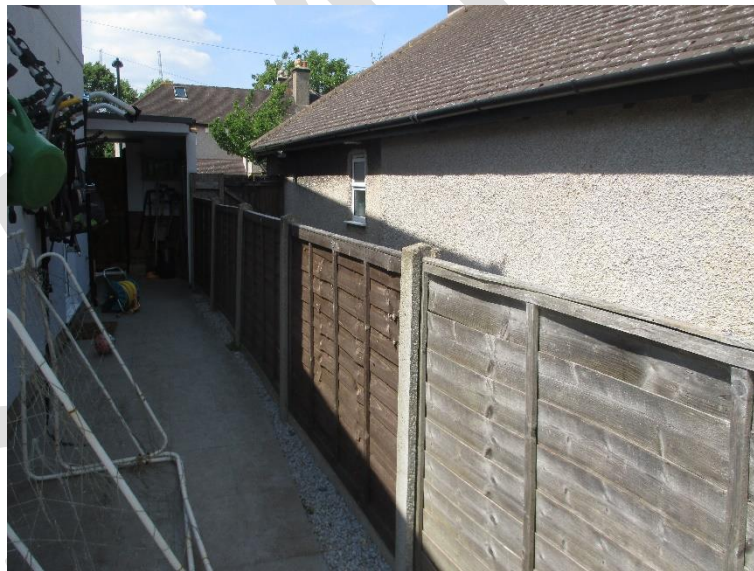
The fences to the boundary are of concrete posts and timber fence panels found to be in reasonable condition to the side elevation.

We would point out that driveways and pathways are generally constructed on minimal foundations and are susceptible to movement, particularly in shrinkable clay sub-soils and, therefore, periodic inspections and patch repairs will be required.

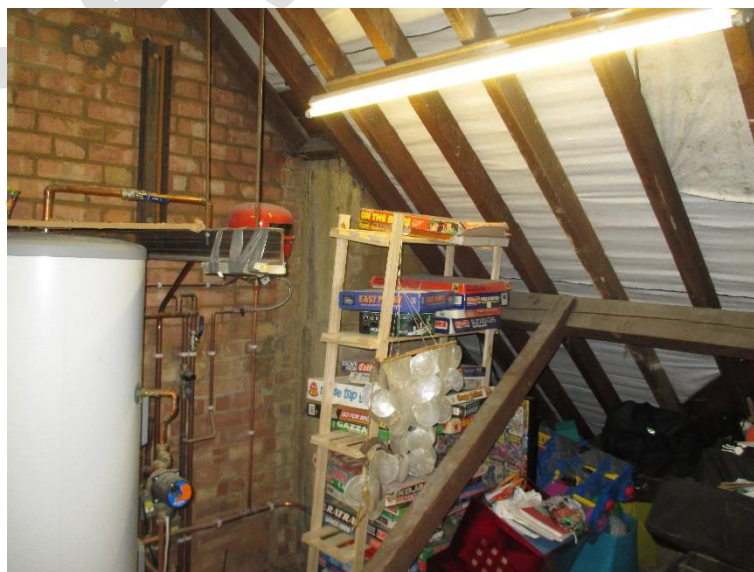
Access was possible into the main roof structure via an access hatch on the first floor landing. Access was gained using the fixed ladder. There is a light fixing therein.

The main roof was found to comprise of pitched rafters supported by a horizontally positioned purlin.

It was not possible to inspect the underside of the main roof covering. This is laid on top of roofing felt which conceals this part of the underside of the surface of the tile. The absence of ventilation between this felt and the underside of the roof covering can reduce the life expectation of the tiles. Without examination, we are unable to determine the level of ventilation that has been provided.

We stress to you that we were unable to gain access to all parts of the roof and therefore not all of the timbers were visible. For this reason, we cannot provide you with any assurances as to the condition of the timbering as a whole.

We confirm that due to the limitations described above (the number of stored items) we are unable to confirm the presence (or not) of woodworm, wet or dry rot. In a property of this age, given a completely free examination, we would have expected to have found some evidence of woodworm infestation. If you have concerns or simply require any further advice in this regard, we recommend you approach a reputable timber specialist company, offering a long term guarantee, to inspect the roof void when it is free of items.

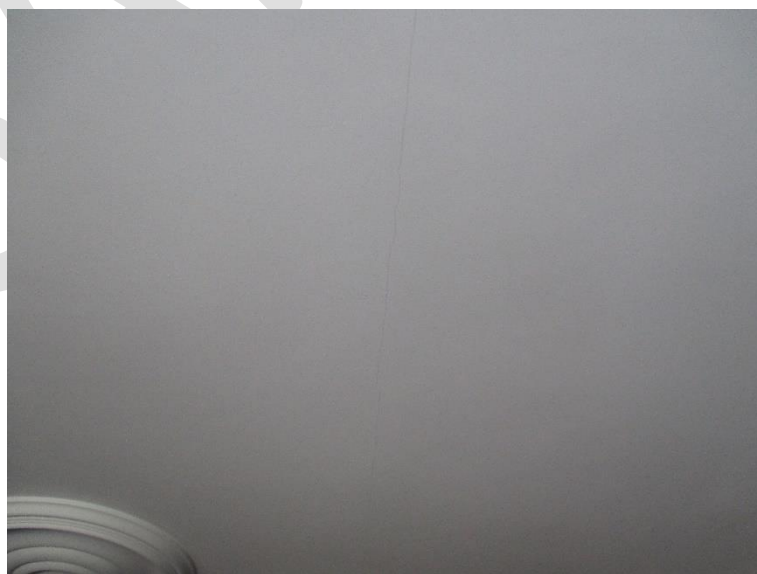
The ceilings are constructed of plasterboard and plaster, there are some classic differential/movement cracking noted to the joints of the plasterboard and also at junctions of walls and ceilings. But this was generally minor in nature and capable of being filled prior to the next phase of redecoration.

Otherwise on the date of survey the ceilings were noted to be in good condition.

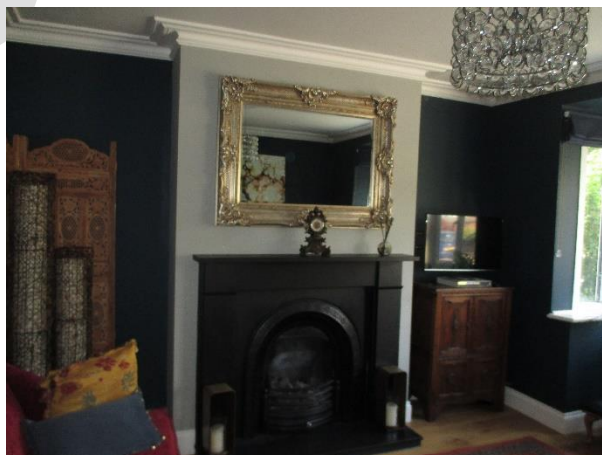
There are open fire place/chimneys in the front sitting room, rear loving room and front and rear right hand side bedrooms.

It is not possible to indicate the condition of the flues or the presence of any flue liners and no assumption has been given as to the practicality of using in the future.

All blocked up flues should be provided with ventilation grills in order to minimise the risk of condensation from occurring within the flues.

Nevertheless, if these fireplaces were to come back into use they should be swept and checked by an engineer specialising in such flues.

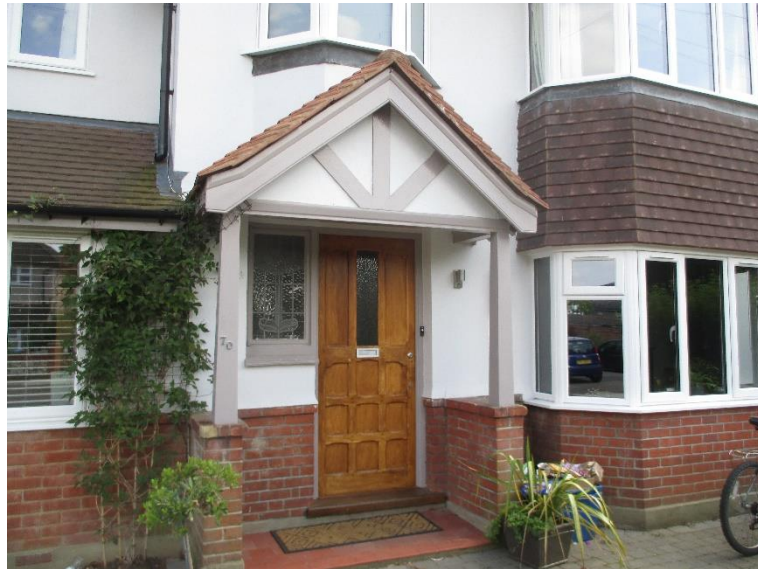
The windows and doors to the property are Uvpc double glazed units with timber door and frames to the main front entrance.

The double-glazing appears in satisfactory condition with no significant defects, except the front left hand bedroom window. It should be noted, however, that double-glazing can vary in quality, particularly in respect of the seals around the edges of the glass. These will deteriorate over time allowing moisture to penetrate between the panes of glass, resulting in misting.
